N05A-7-10-0-70041-01-02 - Habitat Assessment Report - N05a-Riffgat OWF Cable Route Area

MarineSpace Document Ref: J/4/94/2 – HAB Report 02 GEOxyz Document No.: NL4658H-553-RR-14	Originator: Ana Chaverra Valencia
Date: 28/01/22	Circulation: Restricted - Commercial-in-confidence

MarineSpace Ltd was commissioned by GEOxyz on behalf of ONE-Dyas BV, to produce a Habitat Assessment Report for the N05a-Riffgat OWF Cable route in Dutch and German waters. The report aimed to identify the occurrence of species or communities of conservation importance listed under Annex I of the EU habitats Directive (1992) as well as any threatened and/or declining species and habitats on the Oslo-Paris (OSPAR) Commission list (OSPAR, 2008).

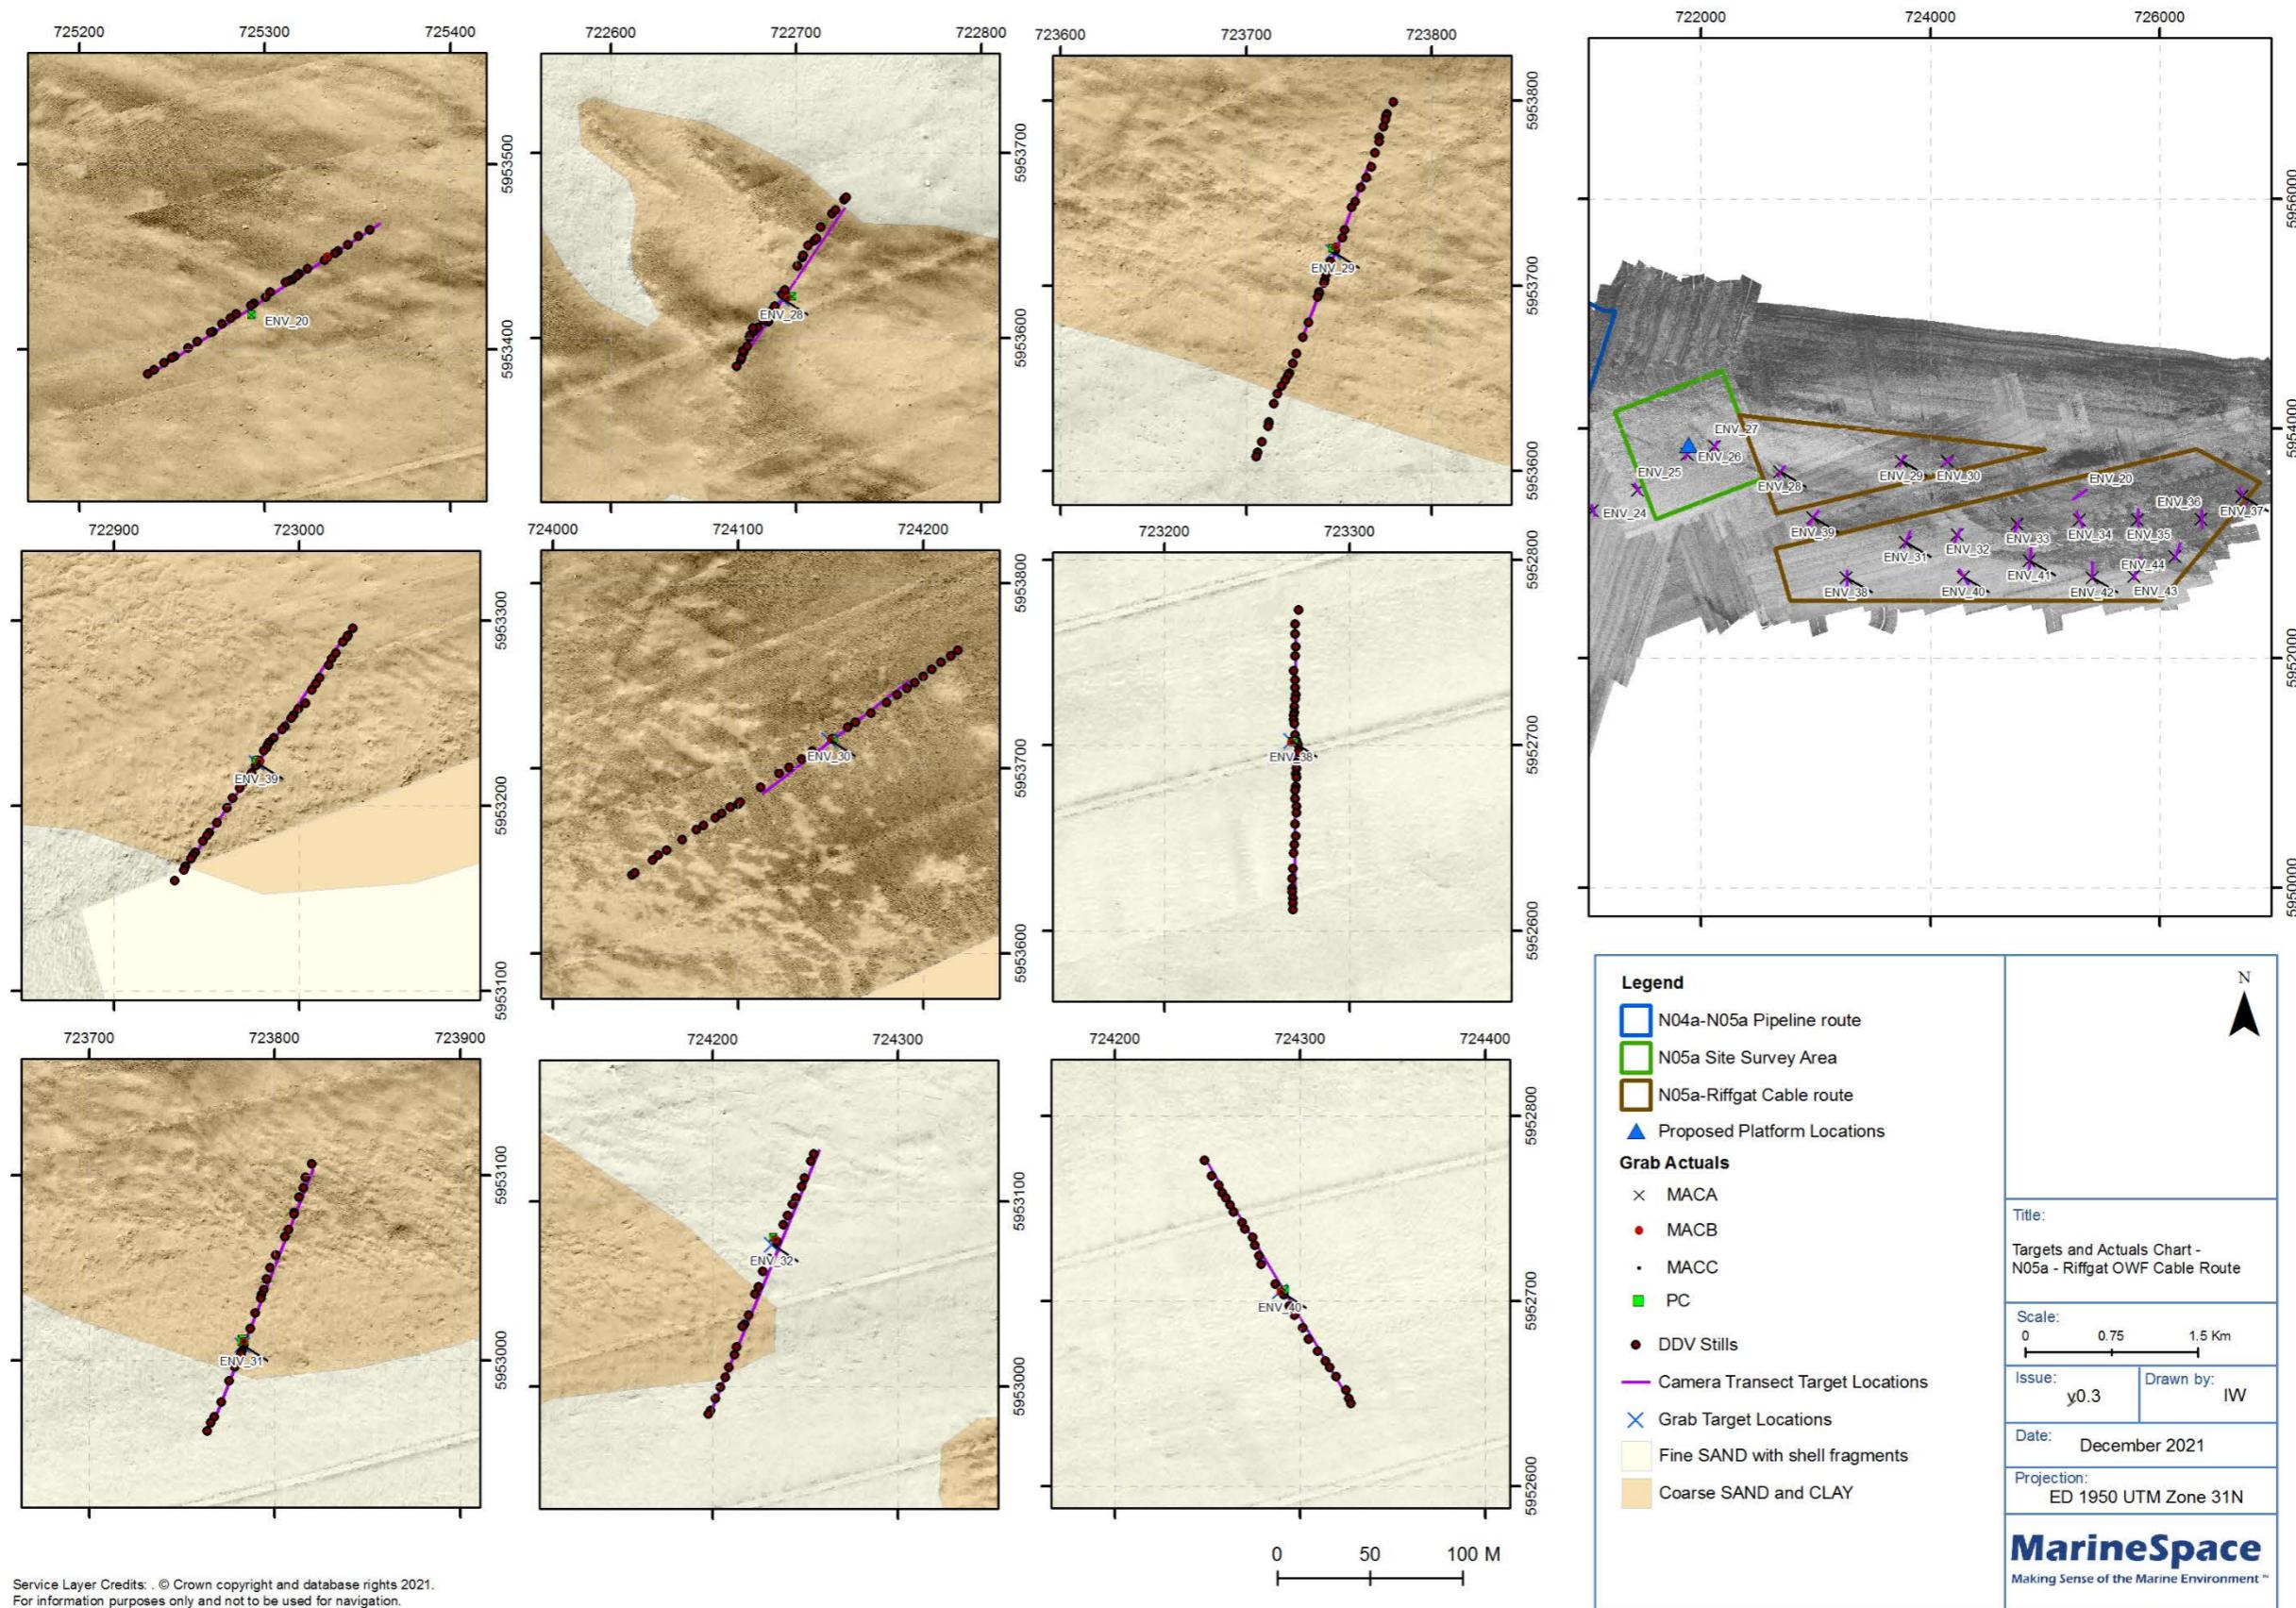
Figure 1.2: N05a-Riffgat OWF cable route including target and actuals, Stations ENV20, ENV28-32, ENV38-40

Details of the environmental targets and data collected along targeted features of interest observed within the geophysical data, are summarised in Table 1.2 for camera transects and in Table 1.3 for grab targets. Target and actual sampling locations, are presented in the Surveyor's log sheets in Appendix A and in Figure 1.2 and Figure 1.3 along with the surveyed 2021 N05a-Riffgat OWF cable route area.

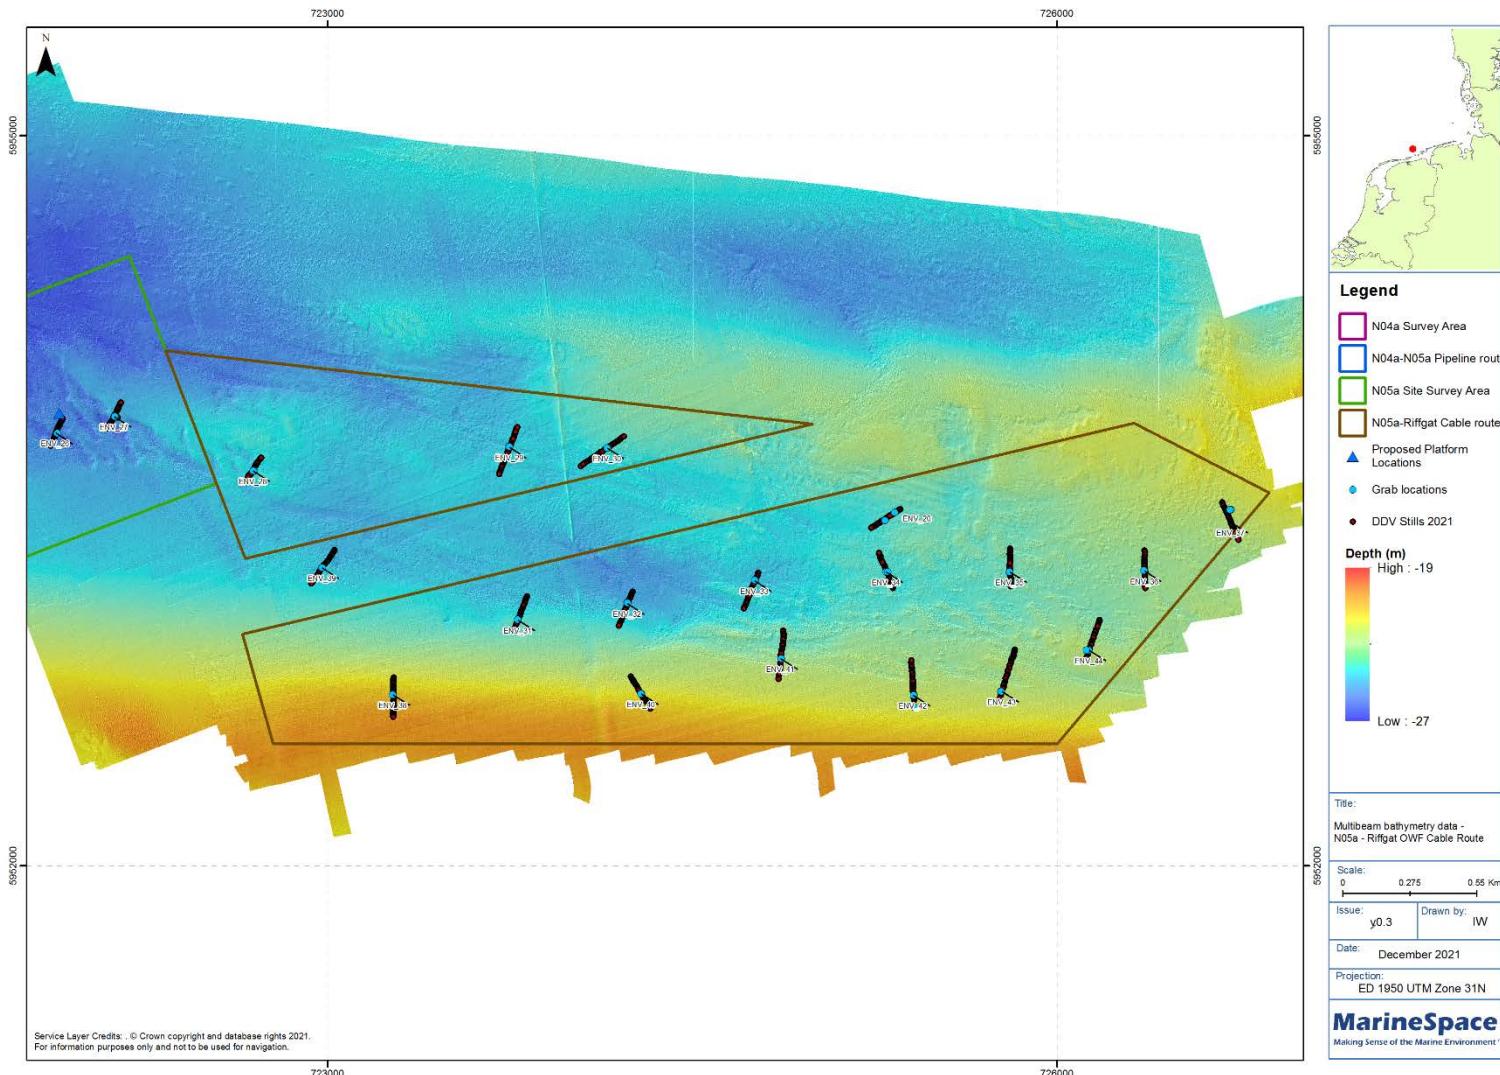
Figure 4.1: Bathymetry across the N05A-Riffgat OWF cable route

Three semi-circular features with 1 m of positive relief, interpreted as being related to previous drilling activity, were imaged in the bathymetry data. They were positioned within a 45 m radius around 721725 m E 5954566 m N and have average dimensions of 30 m x 20 m. The position of the Norned cable was confirmed by MBES data. The cable crosses through the centre of the main body of acquired data in a north/south orientation.

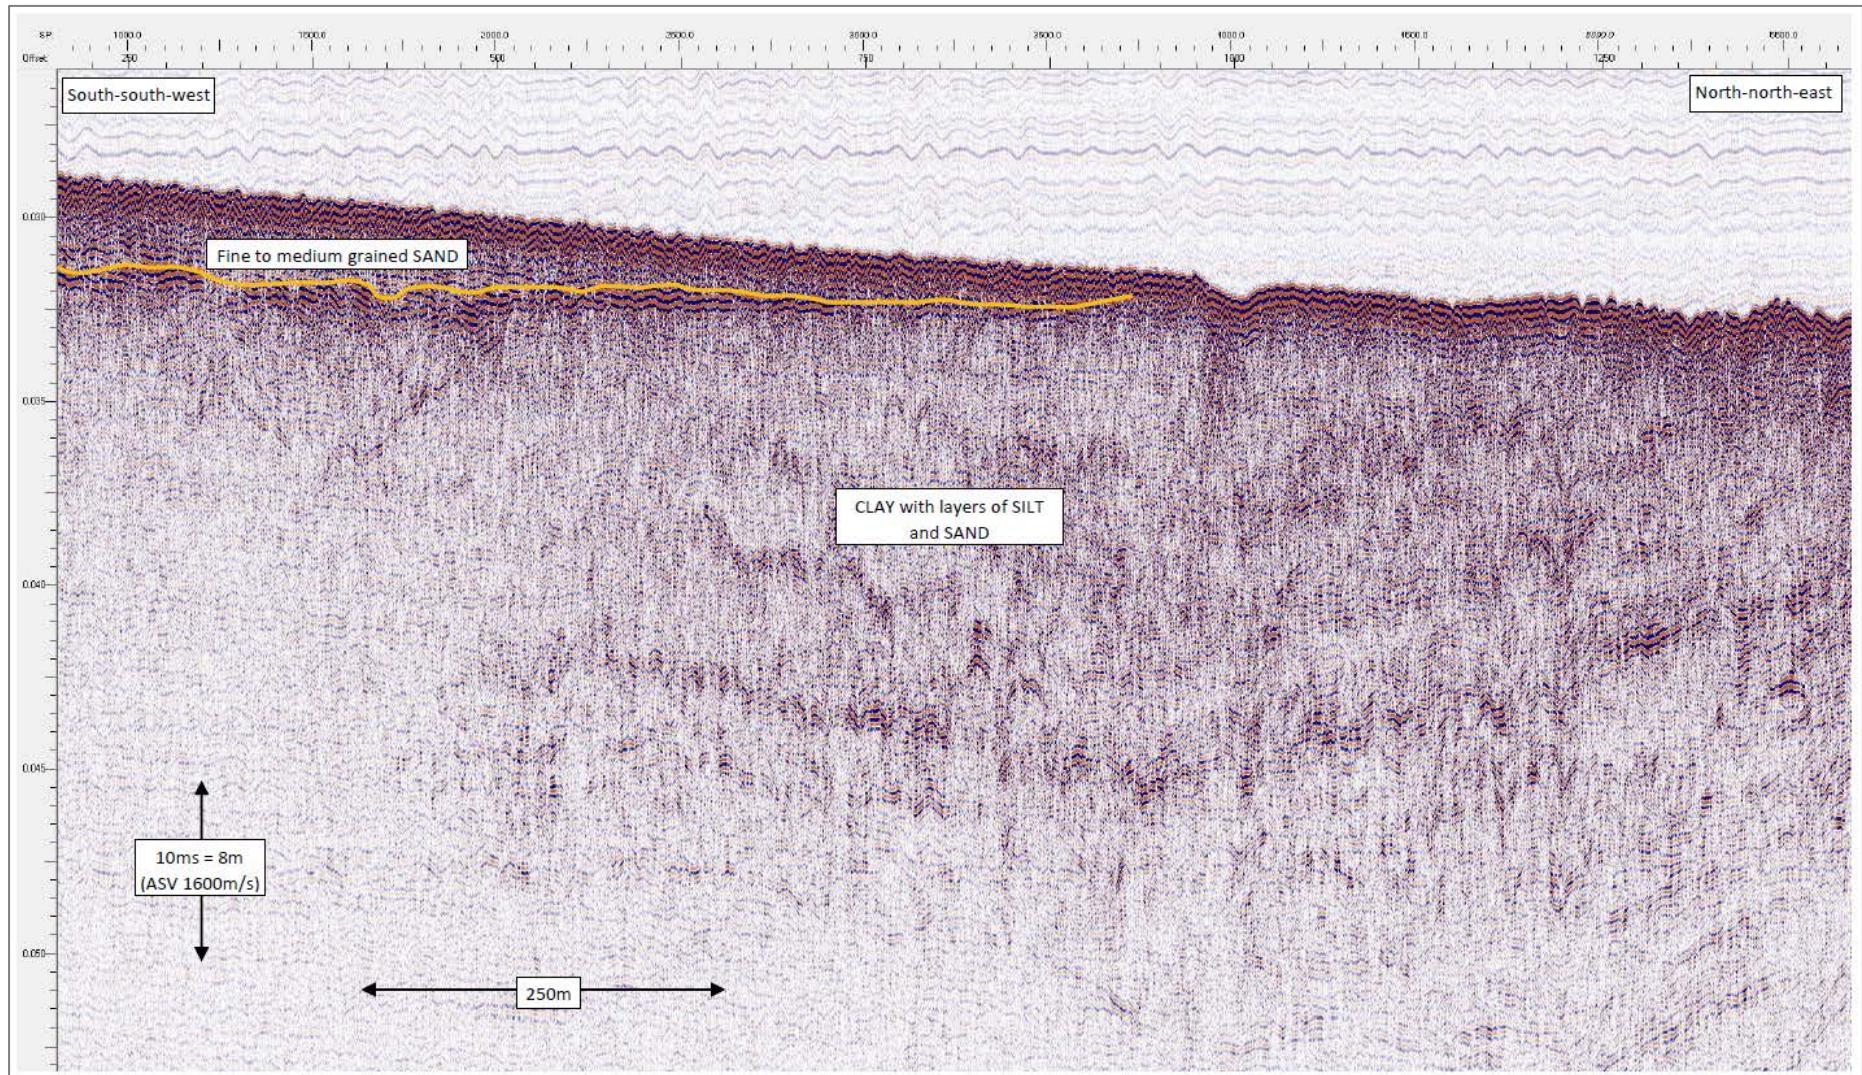
Figure 4.2: Sub-bottom profiler data example for Line CBL_12 (GEOxyz, 2021c)

In the east where the upper unit was present based on vibrocore data it was expected to be subcropped by fine sand.

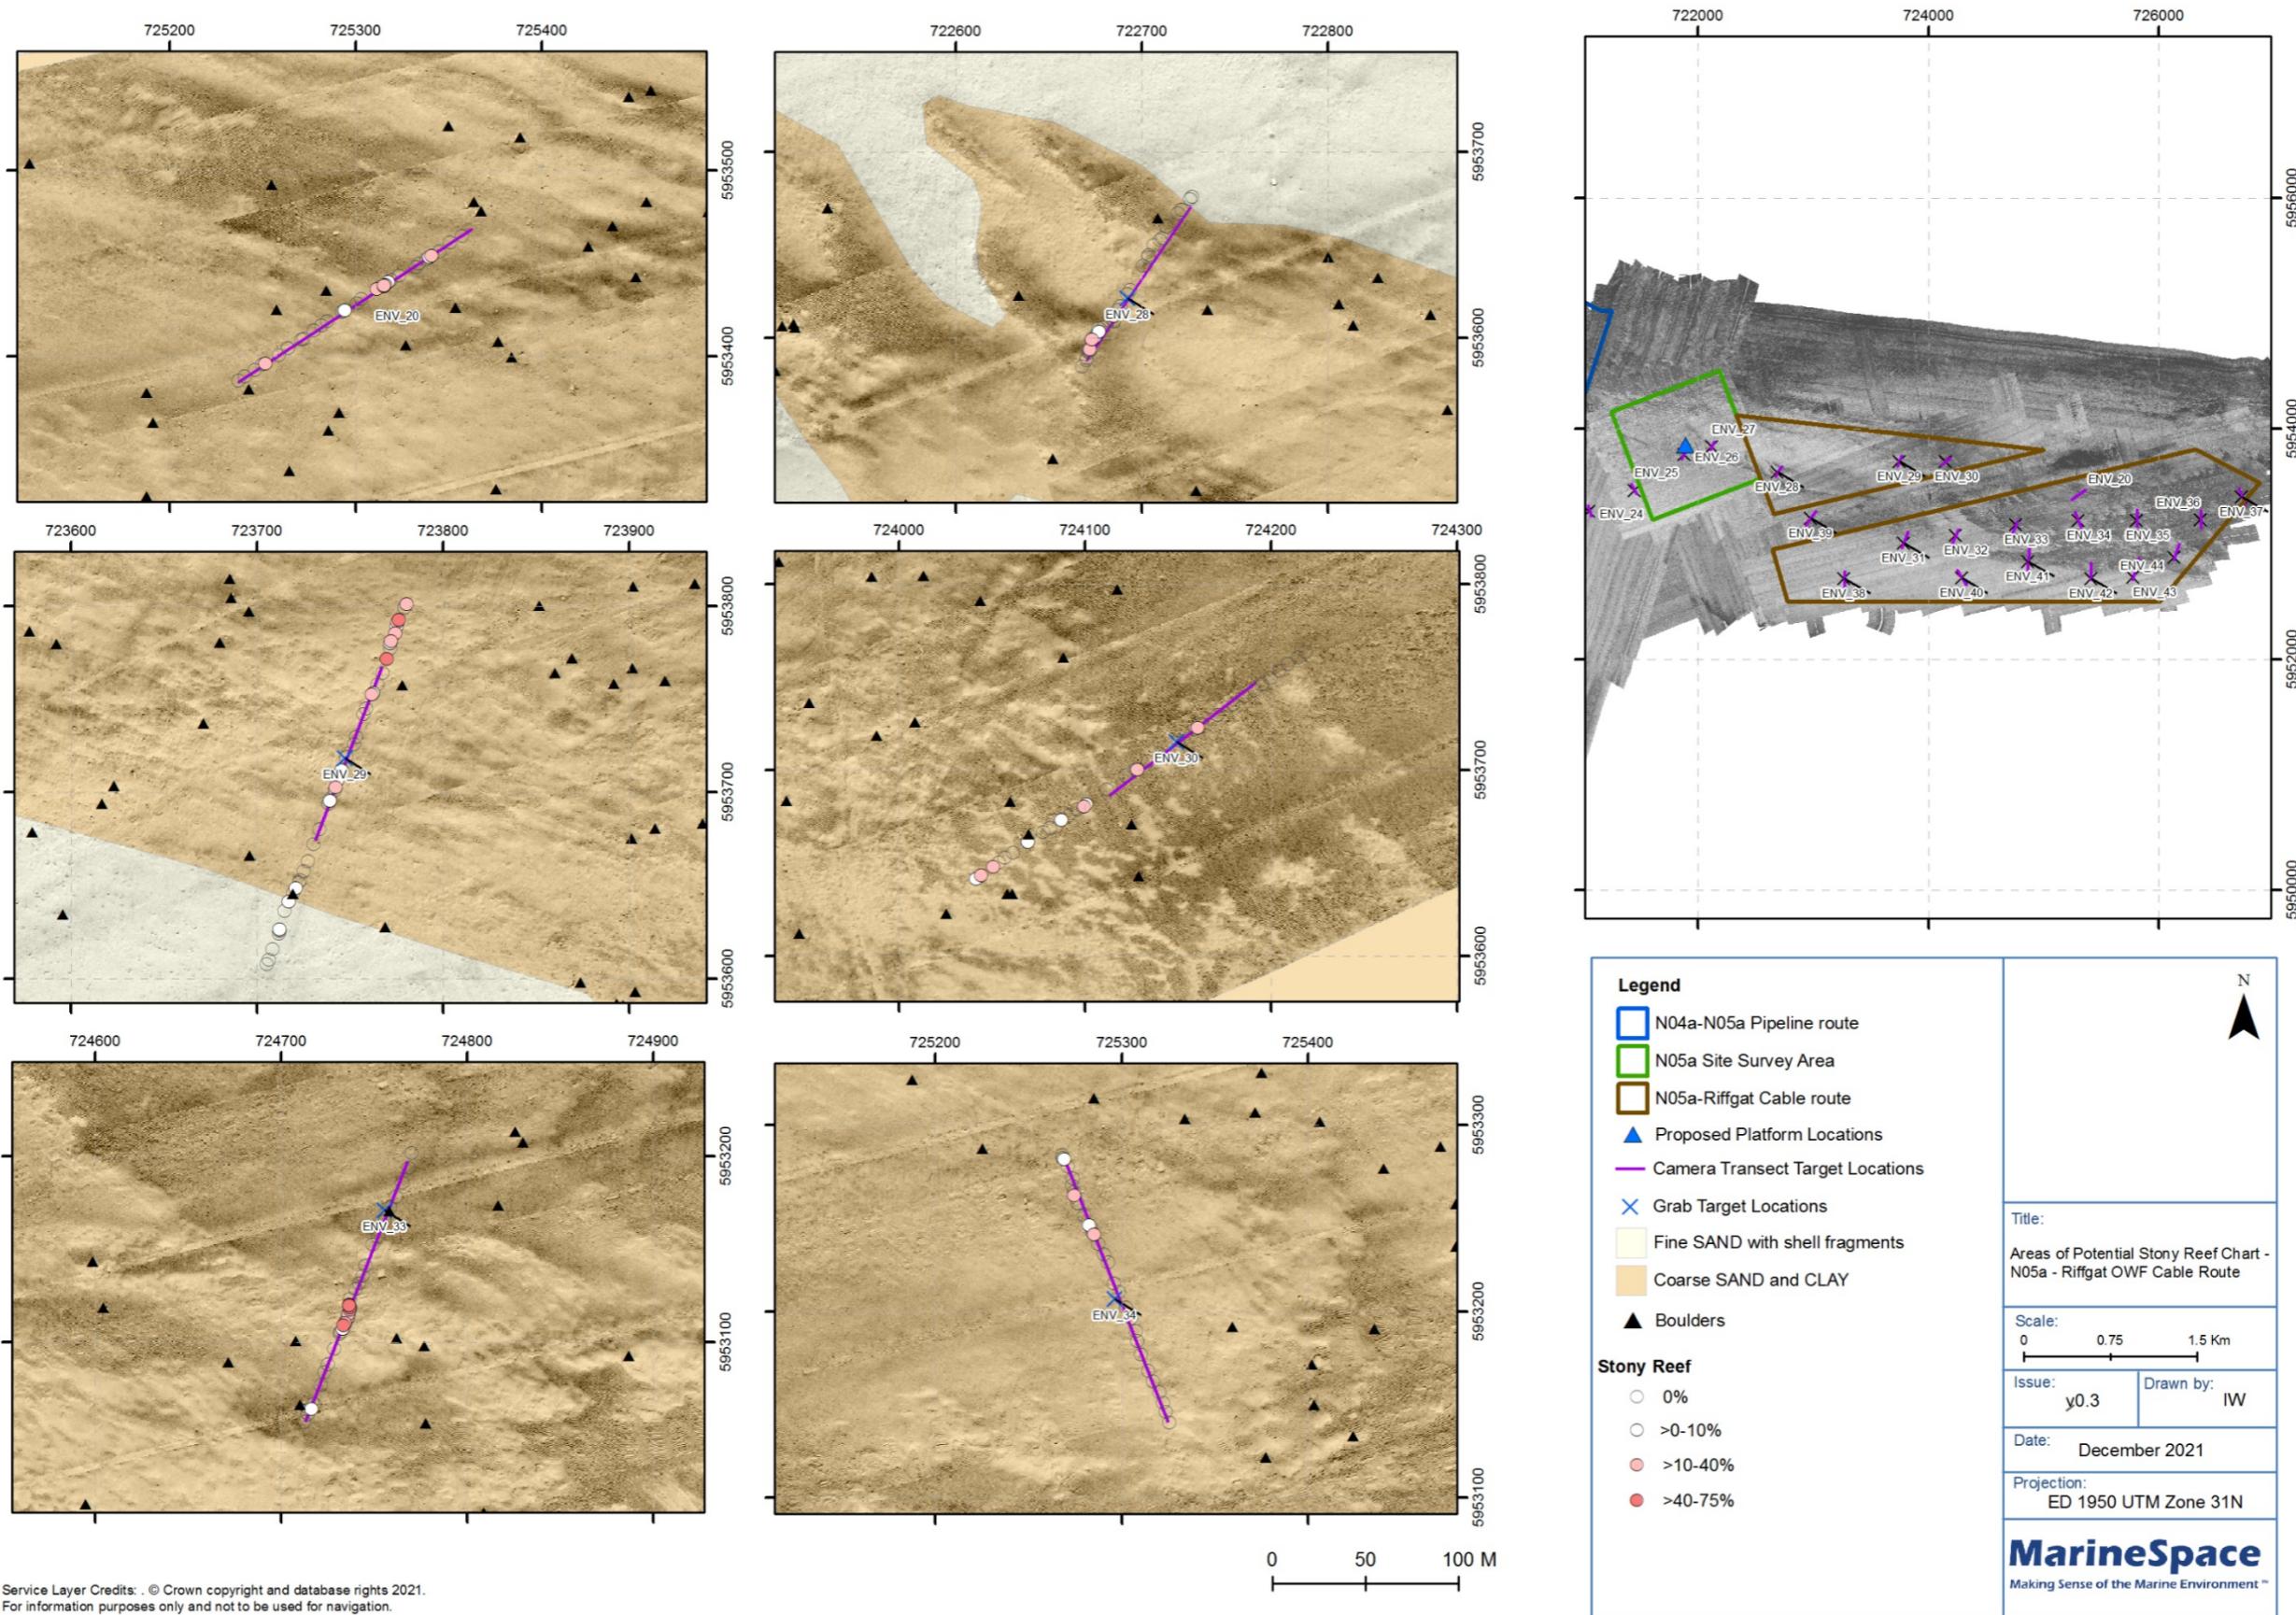
Figure 4.4: Areas of potential stony reef within N05a-Riffgat OWF cable route, Stations ENV20, ENV28-30, ENV33-34

Substrate larger than 64 mm (cobbles and boulders) was observed from seabed imagery at 12 stations (ENV20, ENV28-30, ENV33-35, ENV37, ENV39, ENV41, ENV43-44). Cobbles and boulders were generally associated with epifauna, most frequently *Metridium dianthus*. Cobbles and boulders were observed rarely amongst most stations, except for Stations ENV29, ENV33, ENV20 and ENV30 where they were observed in 42%, 37%, 28% and 26% of the DDV imagery, respectively. Although maximum percentage cover of cobbles and/or boulders was 75% at Station ENV29, 70% at ENV33 and 20% at station ENV20 and ENV30, average % cover across all images was lower than 15% (see Figure 4.4).

There was no obvious topographic difference in the SSS mosaic in areas where cobbles and boulders were observed. However, observed areas of cobbles and boulders were limited to the 'coarse sand and clay' sediment boundary (Figure 4.4 and Figure 4.5). Therefore, patches of cobbles and boulders are expected to be found across this area. This is consistent with the geophysical data which interpreted boulders to occur across this sediment boundary in high densities (see Section 4-1). Cobble and/or boulder areas observed from all transects were generally spaced at distances greater than 20 m.

Based on Dutch MANFQ habitat profile (MANFQ, 2014a), the stony areas observed and identified from the 2021 DDV data were not functionally related and therefore did not form a habitat type greater than 100 m². In addition very few typical species were found in association with the observed hard substrate (see Section 4.2.1). These areas, therefore, could not be defined as Reefs (H1170).

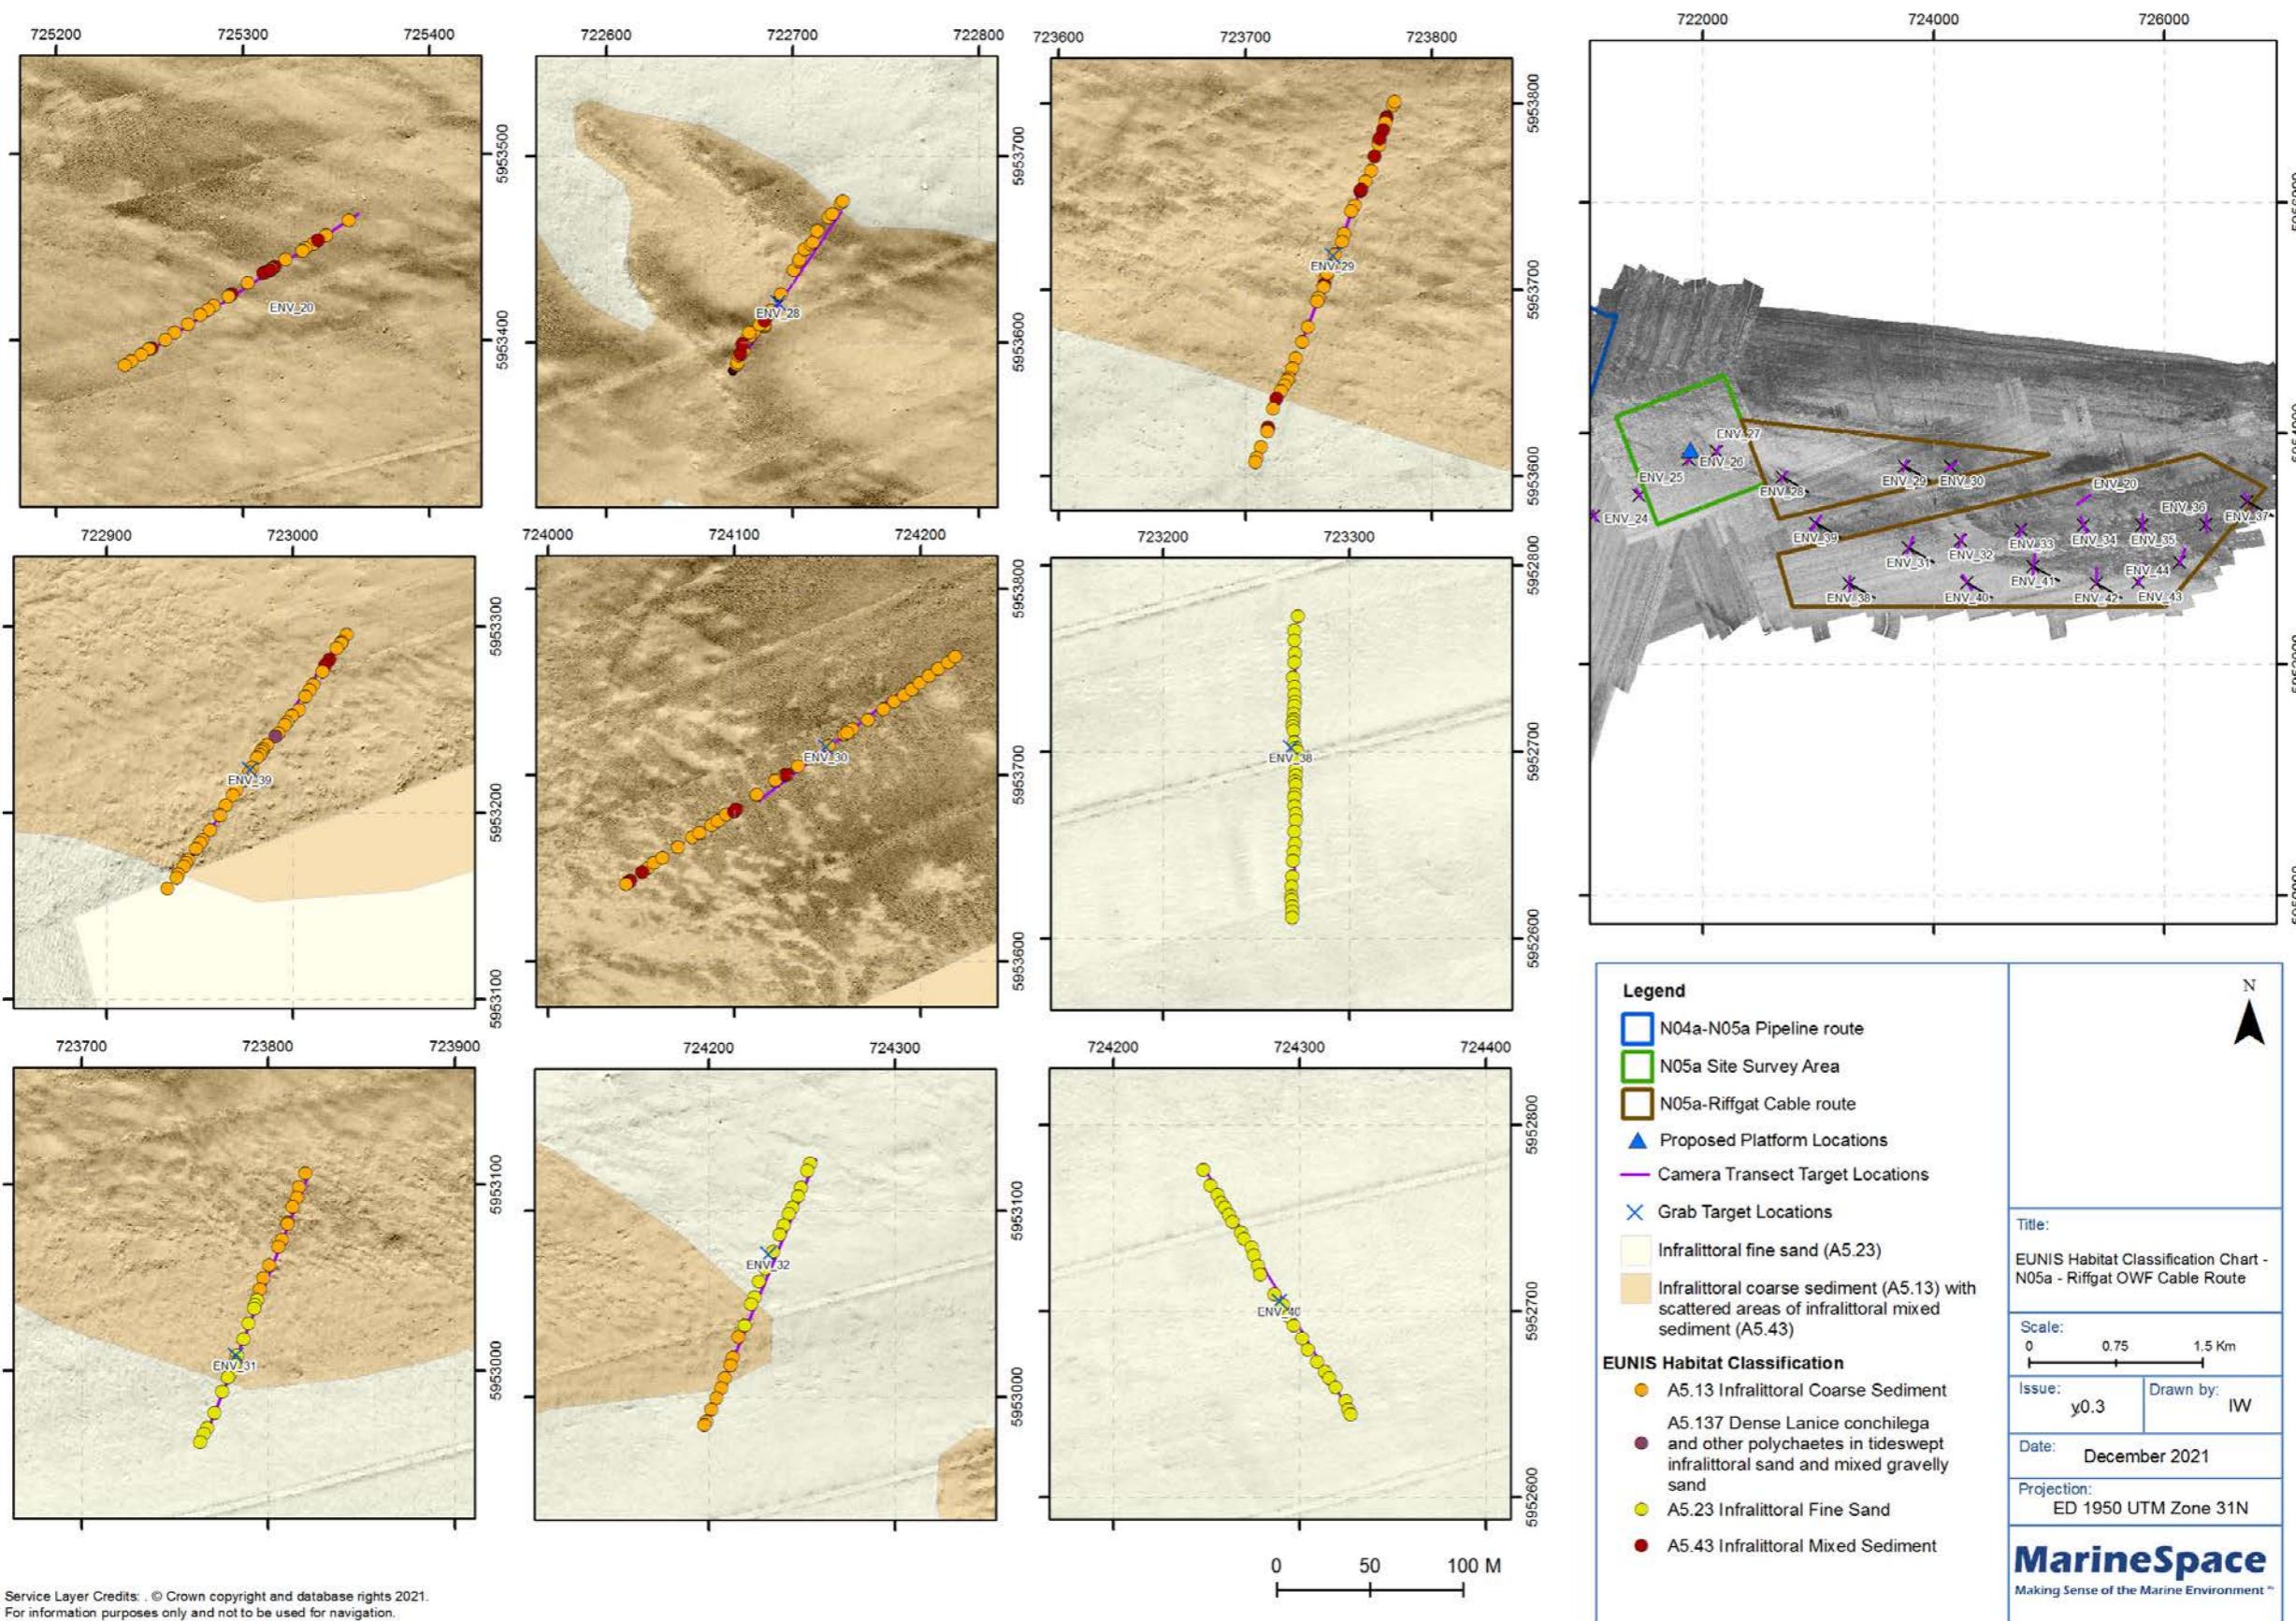
Figure 4.6: EUNIS Habitats identified within N05a-Riffgat OWF cable route area, Stations ENV20, ENV28 – ENV32, ENV38, ENV39 and ENV40

All habitats observed related to the EUNIS level 1 category marine habitats (EUNIS code A) and level 2 category sublittoral sediment (EUNIS code A5), corresponding to sediment habitats in sublittoral near shore zone extending to 200 m depth.

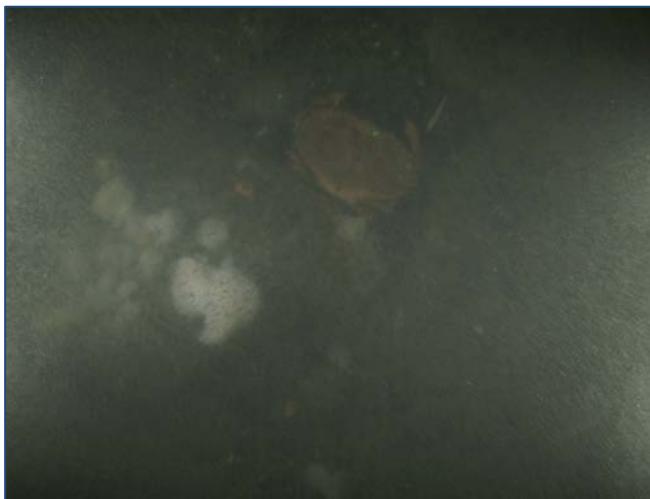
Fix: 281 E: 723776.1 N: 5953792.7 Depth: 24.3 m

Station: ENV 28
Sample: MACB

Sediment Description: Muddy Gravelly Sand (mgs)
Faunal Description: No visible fauna

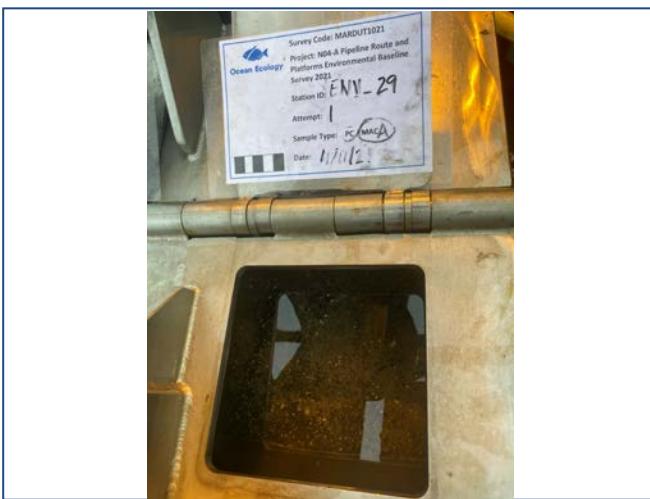
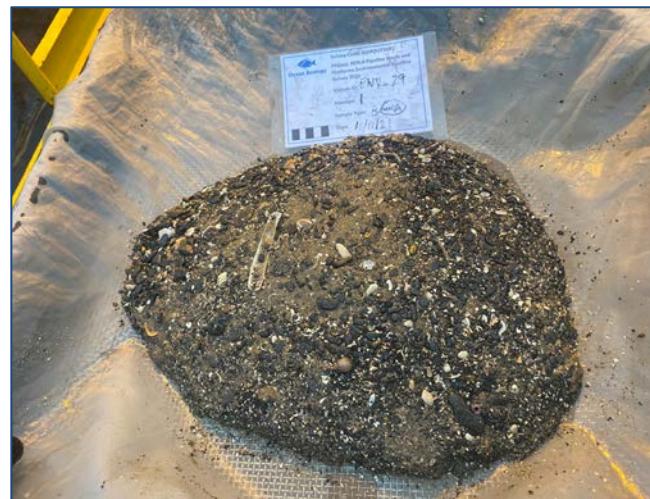
Fix: 55 E: 723746.6 N: 5953720.2 Depth: 21.5 m

Sediment Description: Rippled coarse sand with shell fragments and pebbles

Faunal Description: Hydrozoa

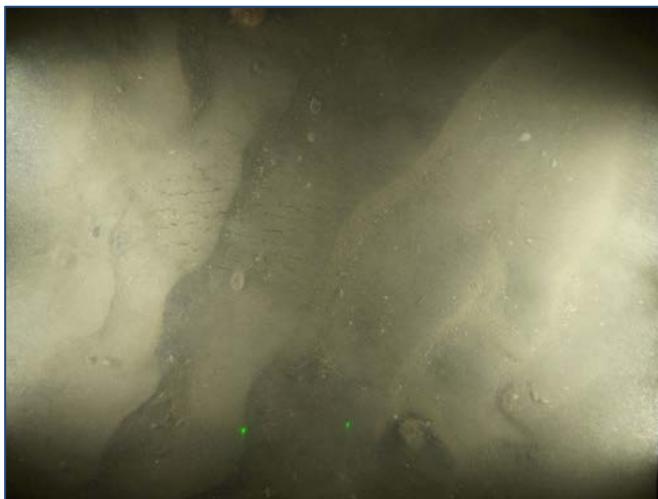
Fix: 901 E: 724227.5 N: 5953062 Depth: 24.1 m

Station: ENV 31
Sample: MACA

Sediment Description: Sandy Mud (sM)
Faunal Description: Polychaeta

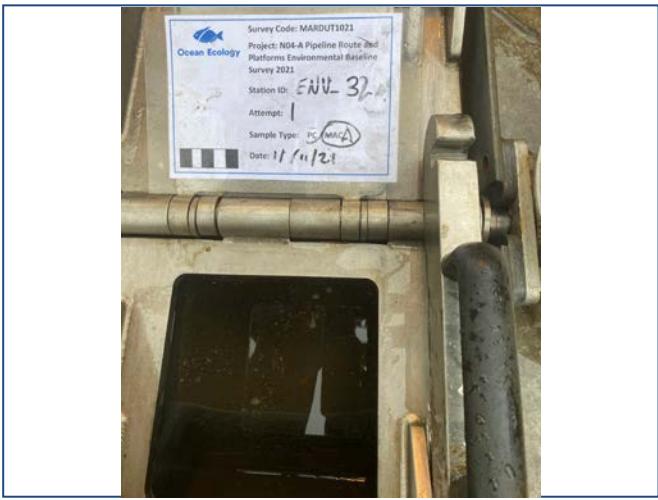
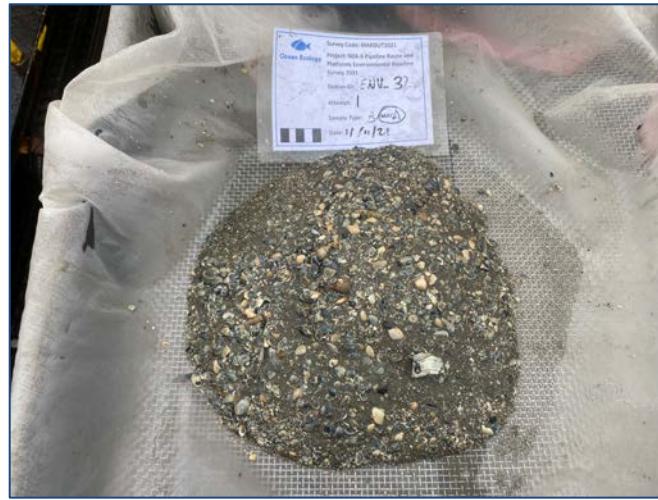
Fix: 49 E: 724232.9 N: 5953080.4 Depth: 24.0 m

Sediment Description: Rippled coarse sand with shell fragments

Faunal Description: *Cylista* sp.; *Lanice conchilega*; *Ophiura albida*; *Ophiura ophiura*

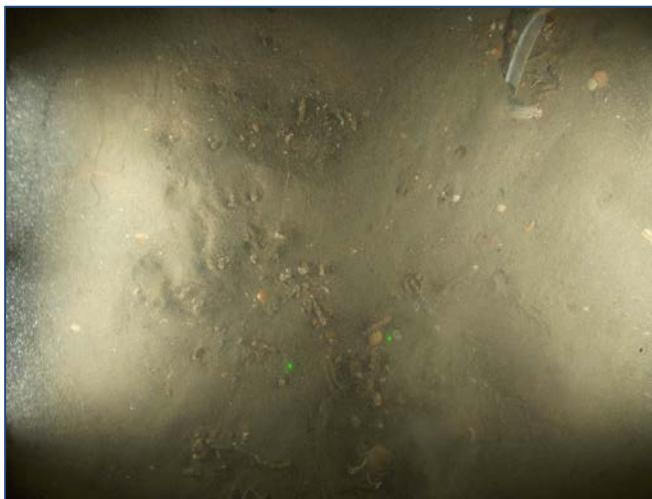
Fix: 971 E: 724765.5 N: 5953185.6 Depth: 24.2 m

Station: ENV 32
Sample: MACA

Sediment Description: Sandy Mud (sM)

Faunal Description: *Lanice conchilega*

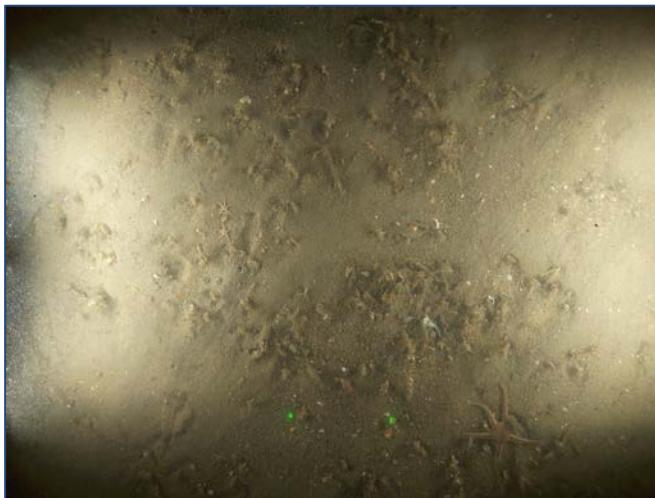
Fix: 1168 E: 726699.5 N: 5953449.1 Depth: 22.2 m

Station: ENV 36
Sample: MACA

Sediment Description: Sand (S)
Faunal Description: *Lanice conchilega*

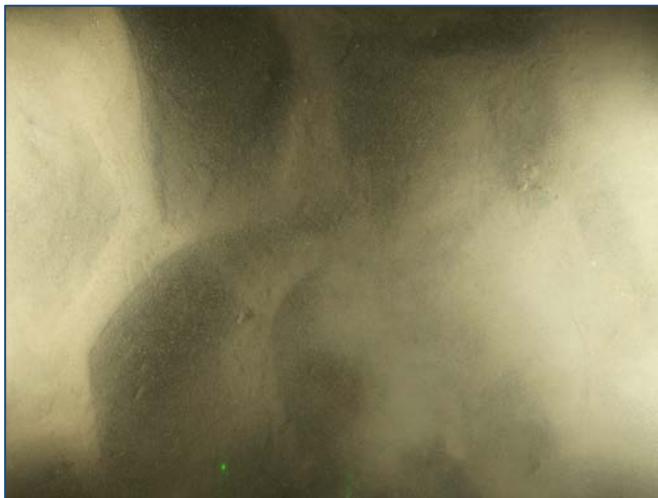
Fix: 765 E: 723270.2 N: 5952720.8 Depth: 20.3 m

Station: ENV 37
Sample: MACA

Sediment Description: Sand (S)
Faunal Description: *Lanice conchilega*

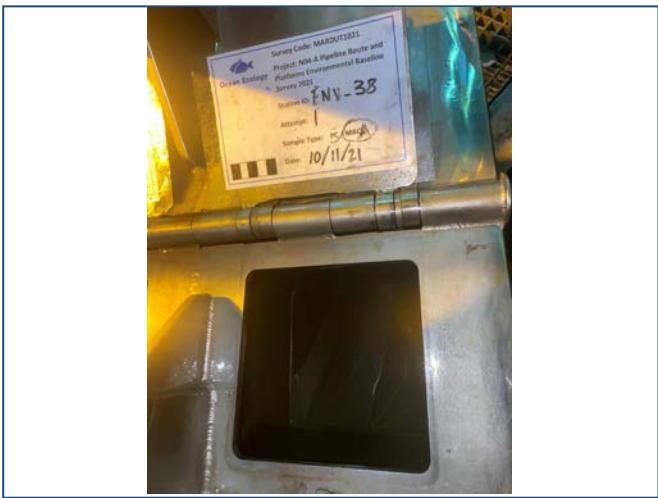
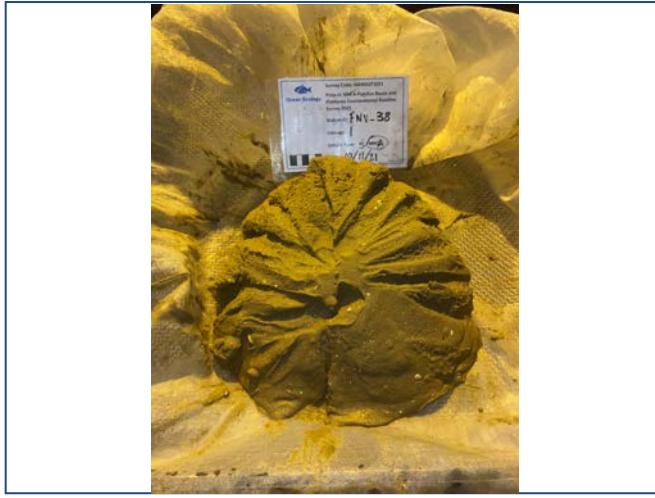
Fix: 59 E: 723269.5 N: 5952702.0 Depth: 23.9 m

Sediment Description: Rippled sand with rare shell fragments

Faunal Description: *Lanice conchilega*

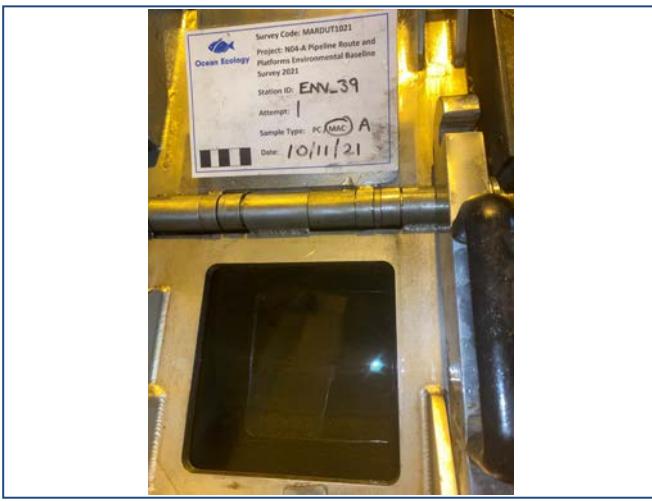
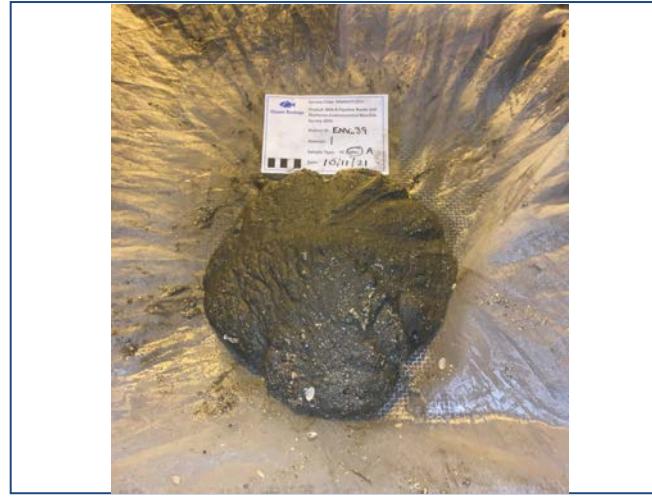
Fix: 61 E: 722977.2 N: 5953224.4 Depth: 23.6 m

Sediment Description: Rippled coarse sand with shell fragments

Faunal Description: *Astropecten irregularis*; *Clysta* sp.;
Lanice conchilega; *Ophiura albida*

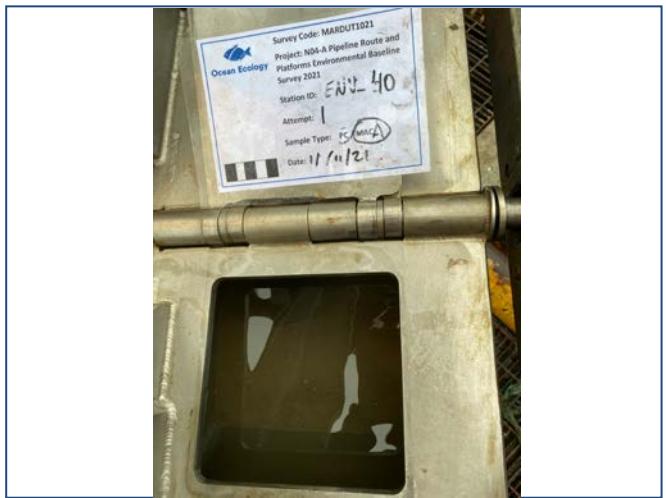
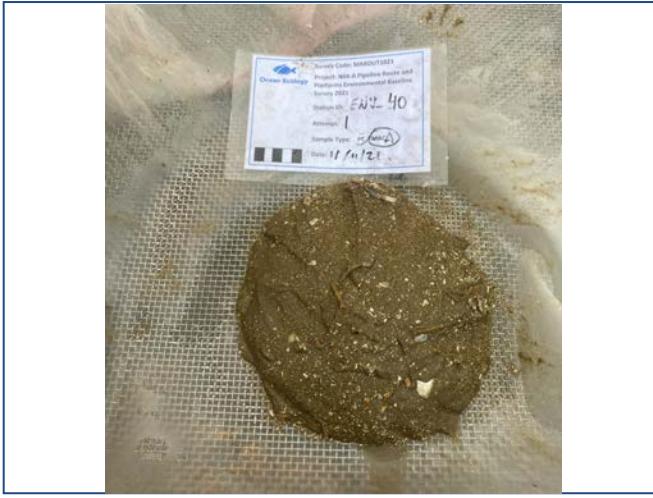
Fix: 51 E: 724292.0 N: 5952706.2 Depth: 21.0 m

Sediment Description: Rippled sand with rare shell fragments

Faunal Description: *Lanice conchilega*

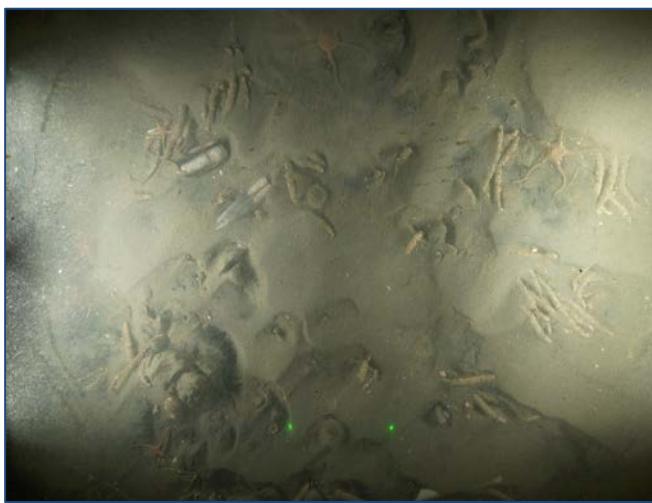
Fix: 1090 E: 725811.6 N: 5952838.4 Depth: 22.6 m

Sediment description: Sandy Mud (sM)

Faunal Description: *Cylista* sp., *Lanice conchilega*

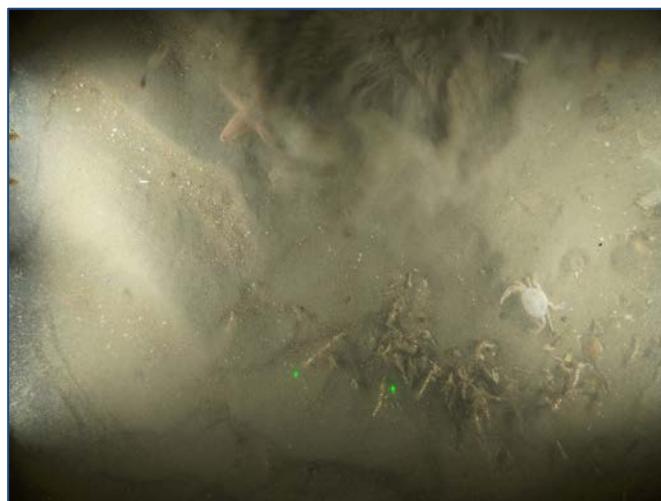
Fix: 1142 E: 726160.5 N: 5952963.9 Depth: 22.4 m

Sediment Description: Sandy Mud (sM)

Faunal Description: *Lanice conchilega*, *Spatangoida*

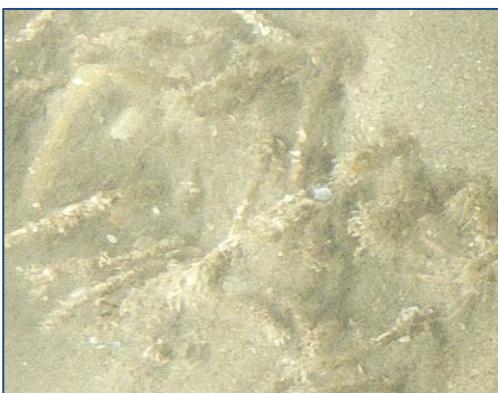
Annelida – *Lanice conchilega*

Polychaete worm which makes a tube out of sand grains and shell fragments, which has a characteristic frayed end that protrudes above the sand.

The most frequently observed taxa within the images was the sand mason worm *L. conchilega* (65%) followed by burrowing anemone *Cylista* sp. (48%) and brittle star cf. *O. ophiura* (42%).

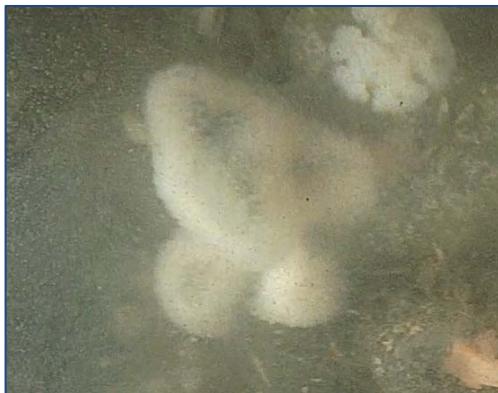
Cnidaria – *Alcyonium digitatum*

Mature colonies form thick, fleshy masses of irregular shape, typically of stout, finger-like lobe.

A. digitatum was observed growing on cobbles along Transect ENV33. *A. digitatum* was the only typical species of Reef (H1170) habitat observed within the seabed imagery and is considered a constant species with indication for good abiotic structure.

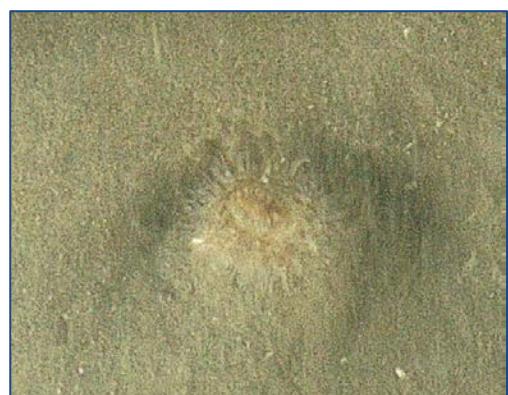
Cnidaria – *Cylista* sp.

Burrowing anemone.

In areas where cobbles and/or boulders were present, *Cylista* sp. was the most frequently observed taxa (59%), followed by plumose anemone *M. dianthus* (48%), Porifera (42%) and *L. conchilega* (23%). On average 0.3 taxa were observed per image in areas with cobbles and/or boulders compared to only 0.06 taxa per image in areas where cobbles and boulders were absent.
