N05A-7-10-0-70041-01-02 - Habitat Assessment Report - N05a-Riffgat OWF Cable Route Area

MarineSpace Document Ref: J/4/94/2 – HAB Report 02 GEOxyz Document No.: NL4658H-553-RR-14	Originator: Ana Chaverra Valencia
Date: 28/01/22	Circulation: Restricted - Commercial-in-confidence

MarineSpace Ltd was commissioned by GEOxyz on behalf of ONE-Dyas BV, to produce a Habitat Assessment Report for the N05a-Riffgat OWF Cable route in Dutch and German waters. The report aimed to identify the occurrence of species or communities of conservation importance listed under Annex I of the EU habitats Directive (1992) as well as any threatened and/or declining species and habitats on the Oslo-Paris (OSPAR) Commission list (OSPAR, 2008).

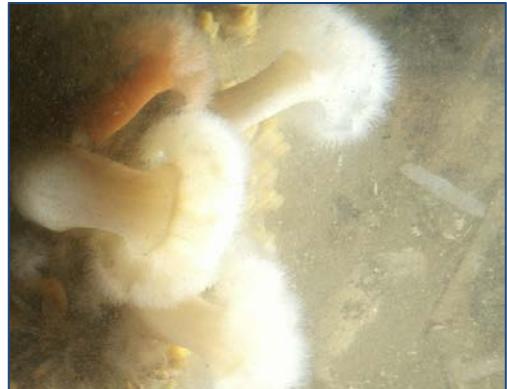
Cnidaria – *Metridium dianthus*

The base is wider than the column and often irregular. When expanded, the numerous tentacles form a 'plume' above a conspicuous parapet at the top of the smooth column.

In areas where cobbles and/or boulders were present, *Cylista* sp. was the most frequently observed taxa (59%), followed by plumose anemone *M. dianthus* (48%), Porifera (42%) and *L. conchilega* (23%). On average 0.3 taxa were observed per image in areas with cobbles and/or boulders compared to only 0.06 taxa per image in areas where cobbles and boulders were absent.

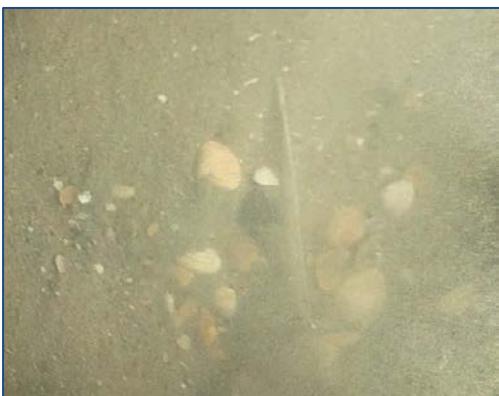
Cnidaria - Pennatulacea

Sea pen

Only 1 individual of Pennatulacea was observed within the N05a-Riffgat OWF cable route area. Consequently, there is little resemblance to sea pens and burrowing megafauna in circalittoral fine mud, which is listed as a threatened and/or declining habitat (OSPAR, 2008).

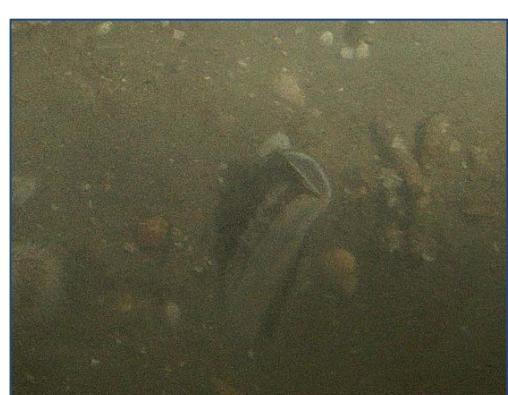
Mollusca – *Bivalvia siphon*

Bivalve siphons
